BEACH EROSION CONTROL REPORT

*SOUTH SHORE OF BARNSTABLE
MASSACHUSETTS
FEBRUARY 1977*

SOUTH SHORE BARNSTABLE, MASSACHUSETTS
BEACH EROSION CONTROL REPORT

BEACH EROSION CONTROL STUDY

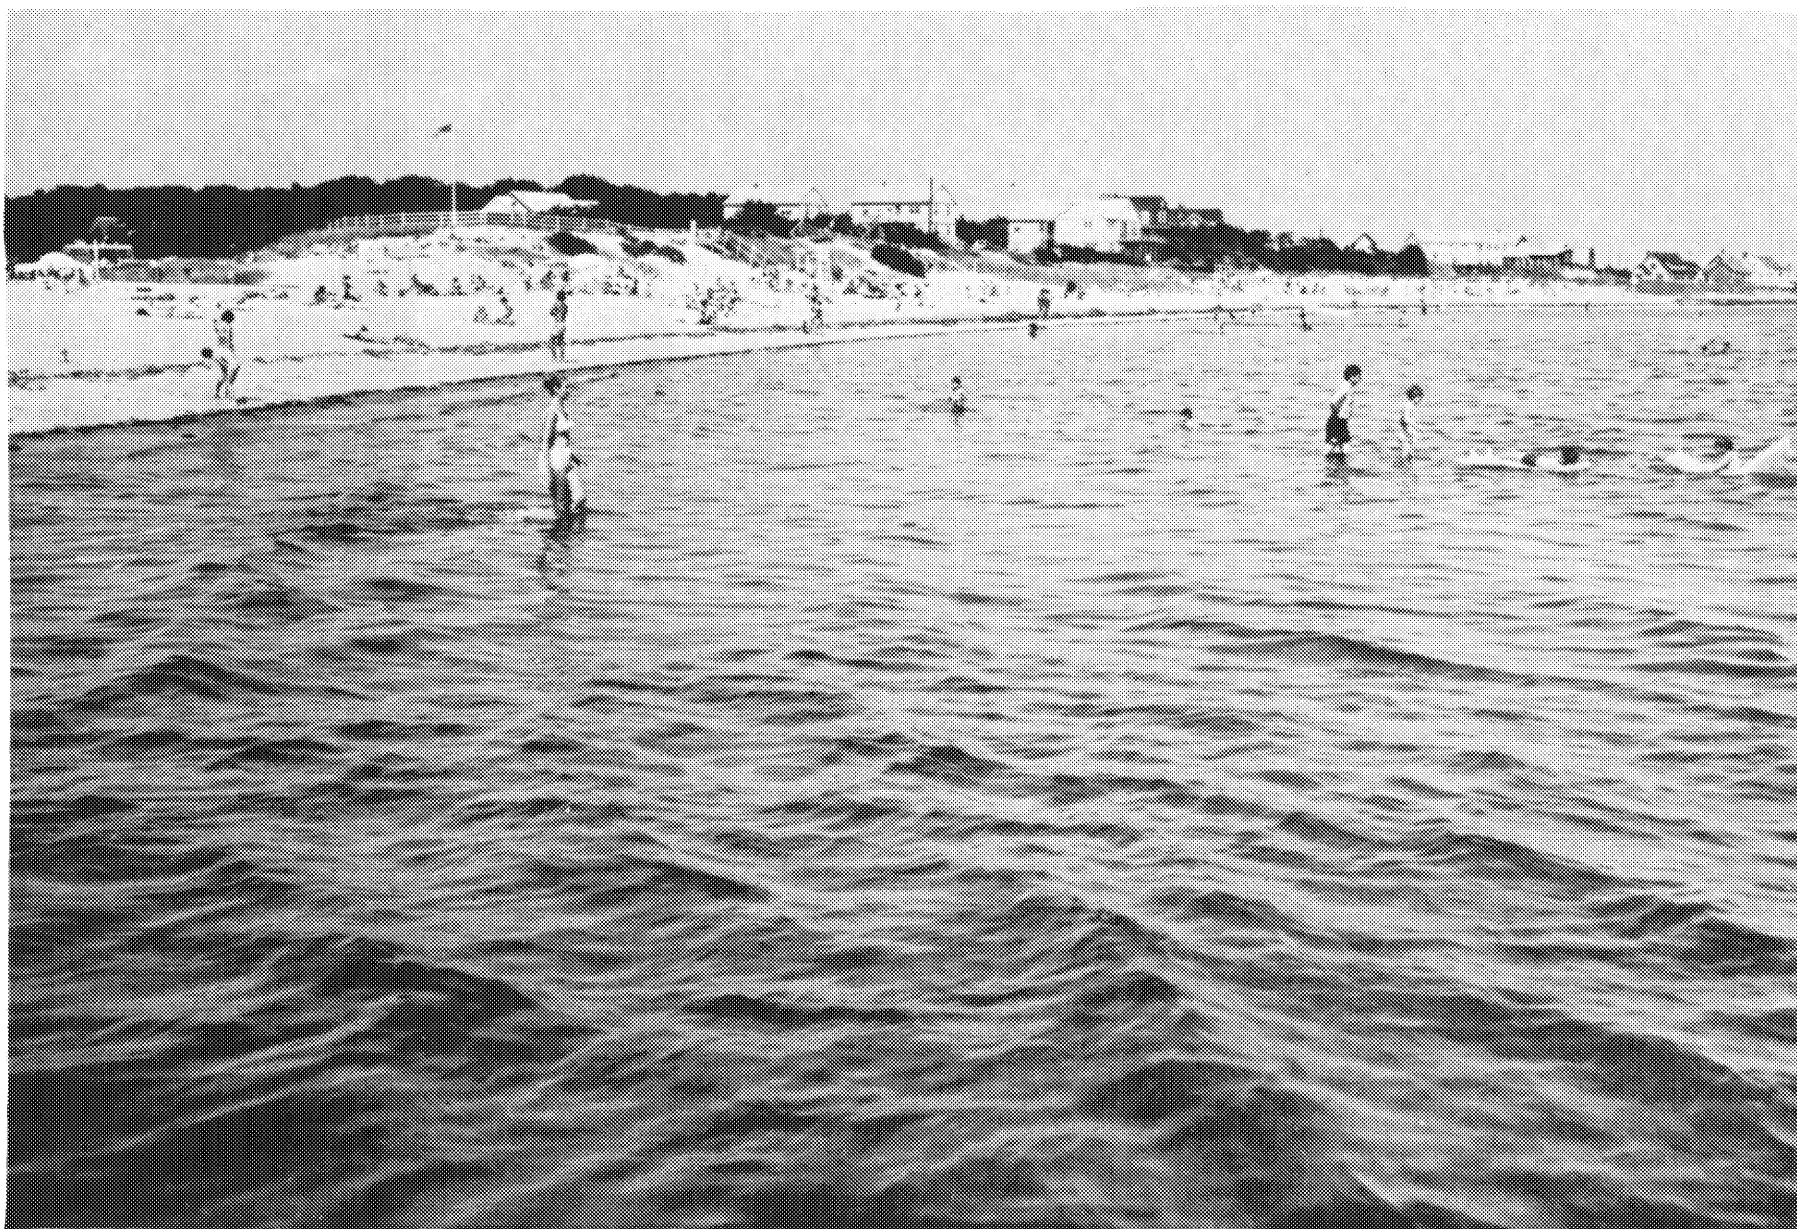
PHOTO 11. July 1971 Keyes Memorial Park Beach looking east, note wide beach area and dunes along the backshore.

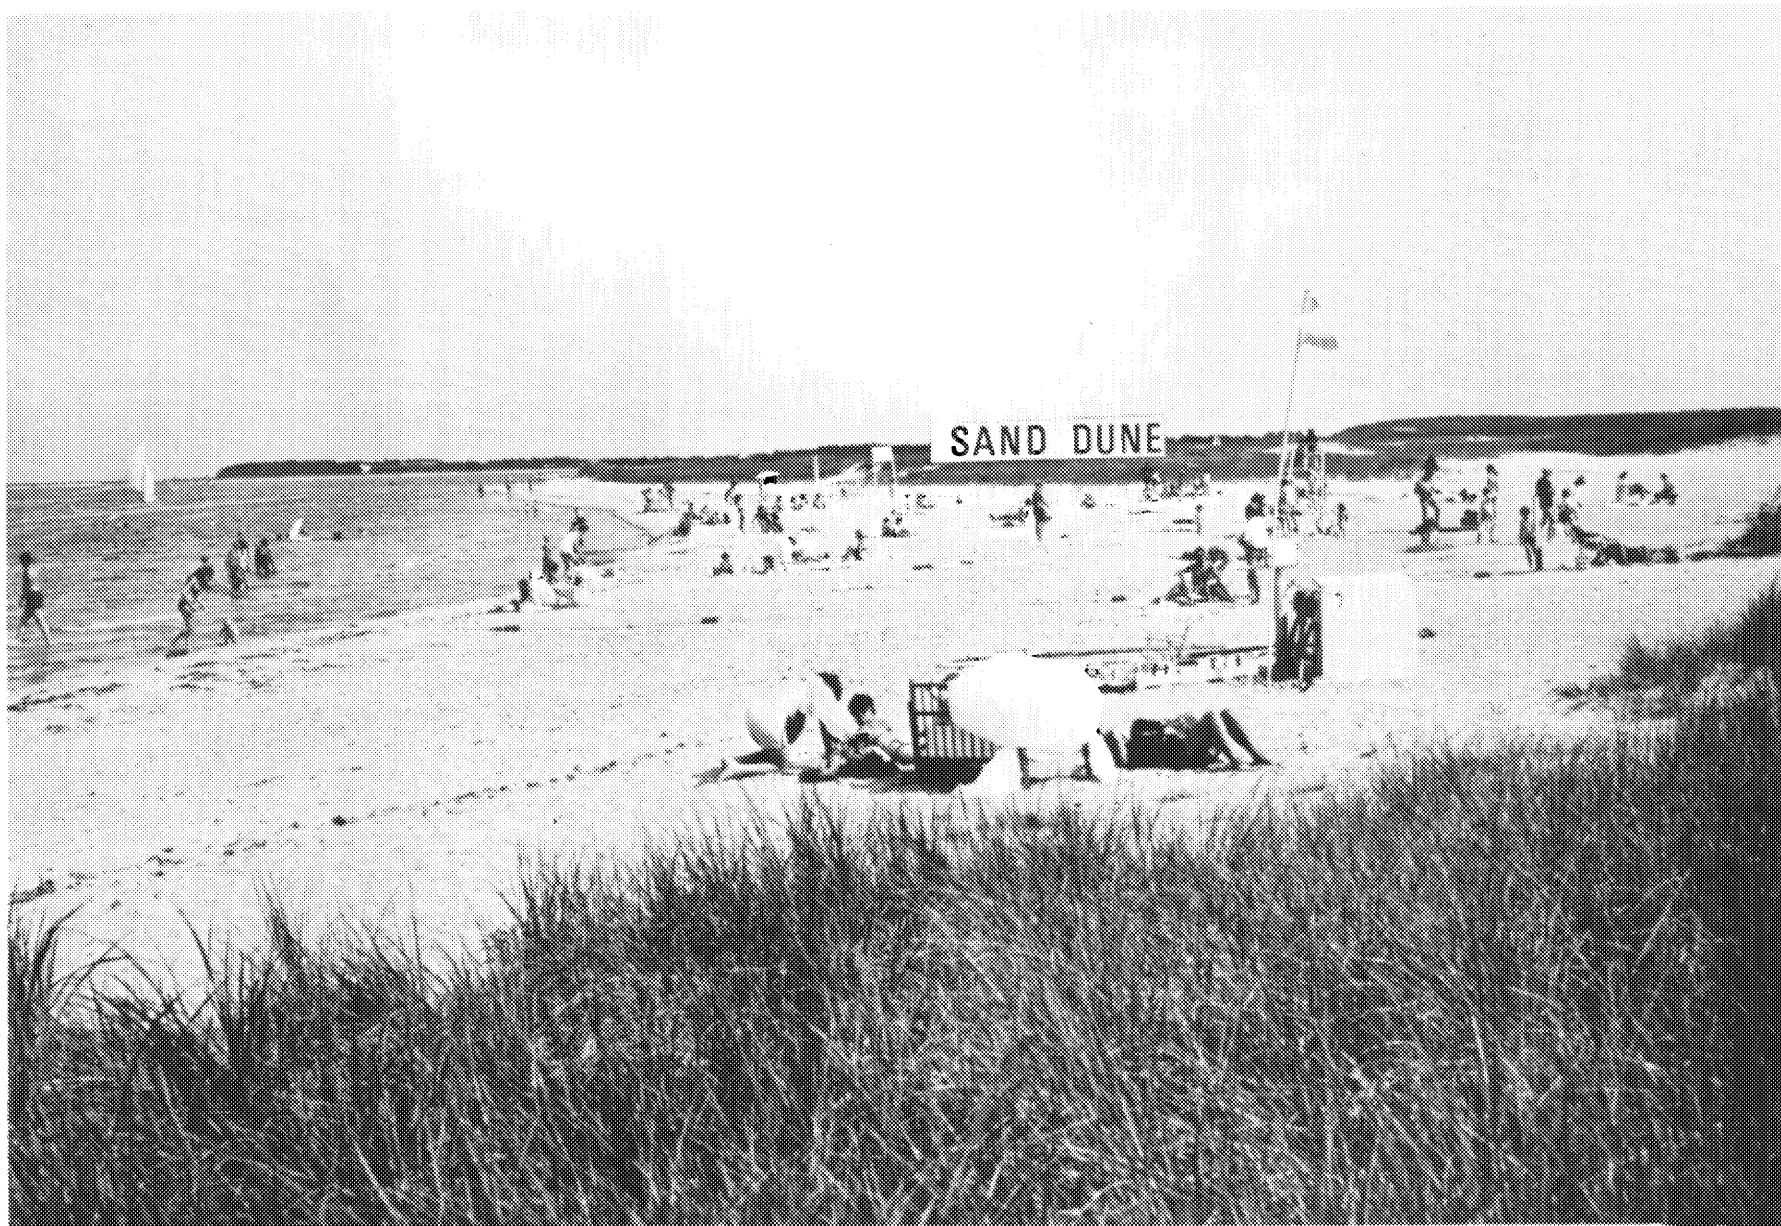
PHOTO 13 - July 1971 Kalmus Park Beach, looking east, note bathhouse in Photo 12, in this photo bathhouse is to the right of flag. The sand dune in the background separates this beach and the beach shown in Photo 12.
